Bodie Island Life-Saving Station & Boat House

Historic Structure Report

Cape Hatteras National Seashore
Bodie Island Life- Saving Station & Boat House
Historic Structure Report

2005

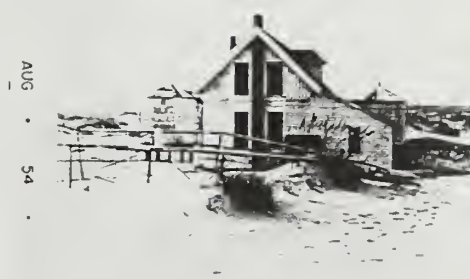
I.11 1879 Station from the northeast ca. 1945. Label – none. Shows boardwalks to rear and front of building. Shows 1925 lean-to and 1916 boat house.

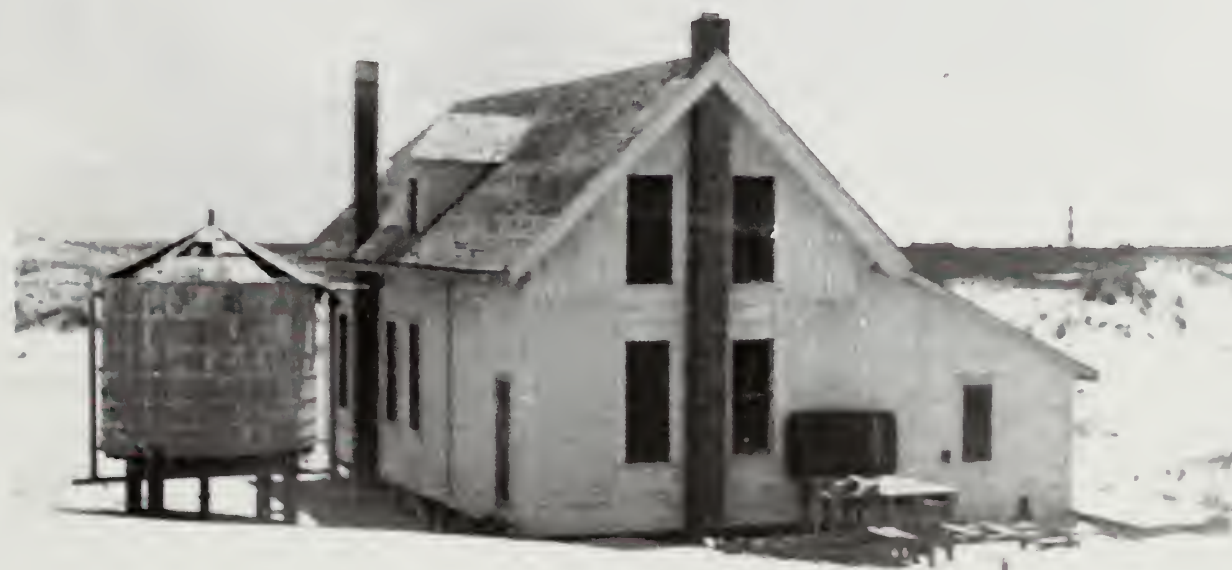
- I.12 1879 Station from the north, dated August 1954. Label – “Neg. No: 54-48, Date: August 1954, Print File: St/OA, General Description, Location, Other pertinent Data: Bodie Island Coast Guard Station before being moved sometime later, for use as Supt’s residence. Negative by: Ludgate Large Print? No”

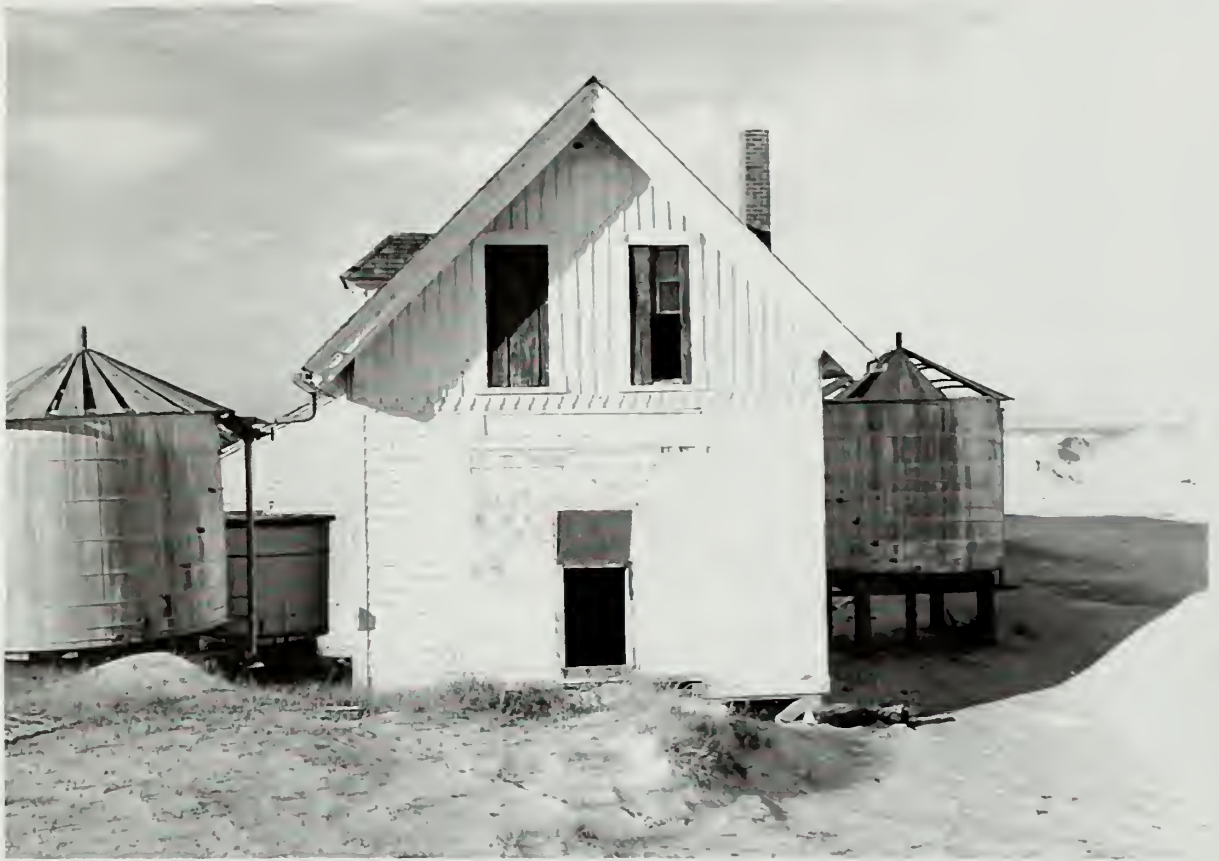
I.15 1879 Station from the southwest, Jan. 10, 1955. Label – “Neg. No: 55-16, Date: 1/10/55, Print File: St/M, General Description, Location, Other pertinent Data: Supt. Residence prior to being moved. Negative by: A.D.” [Albert Dillahunty]

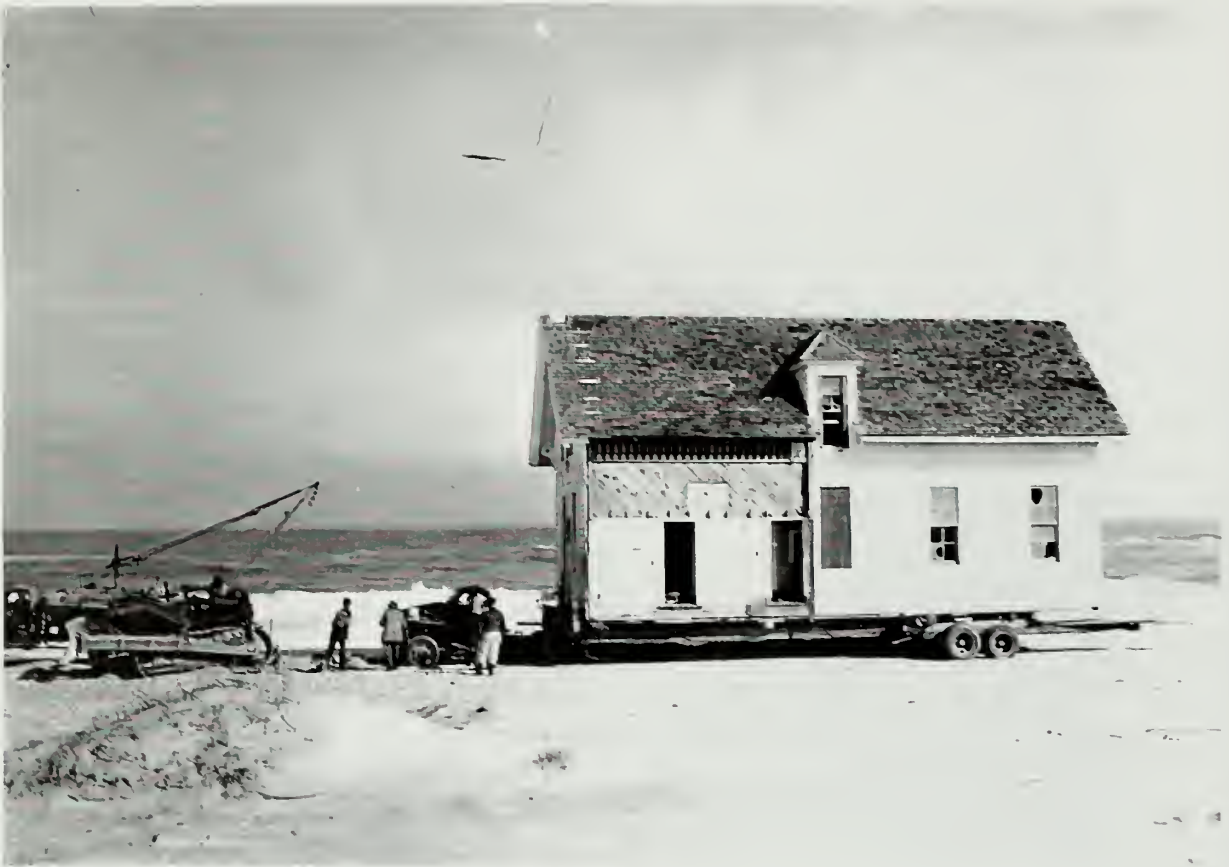
- I.17 1916 boat house from the southeast, Jan. 31, 1955. Label – “Neg. No: 55-18, Date: 1/31/55, Print File: St/M, General Description, Location, Other pertinent Data: Old Bodie Island C. G. boat house prior to being moved into location for Supt’s garage. Negative by: Albert Dillahunty Large print? Yes”. Shows south and east elevations.

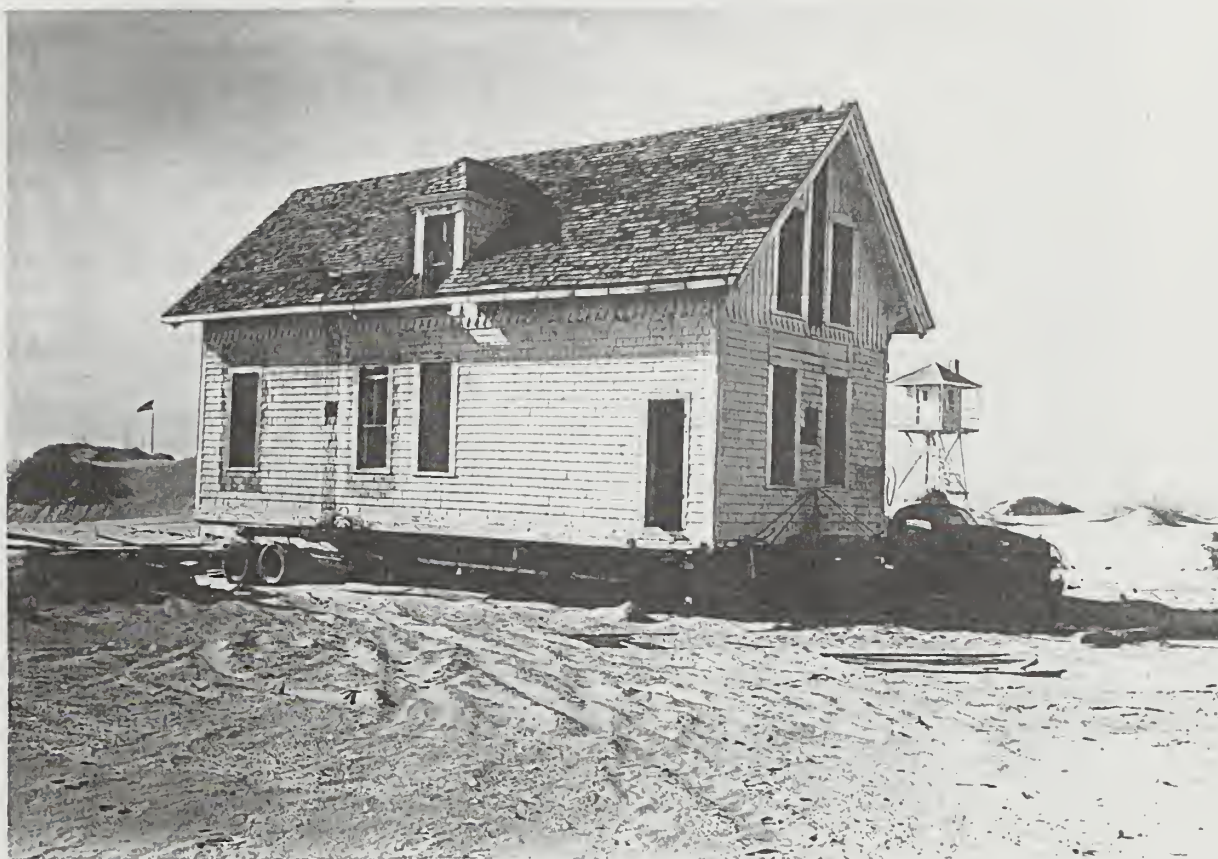
I.18 1879 Station from the east, Jan. 31, 1955. Label – “Neg. No: 55-20, Date: 1/31/55, Print File: St/M, General Description, Location, Other pertinent Data: Supt. Residence being moved. Negative by: A.D.” [Albert Dillahunt]. Shows lean-to removed and evidence of an earlier door location.

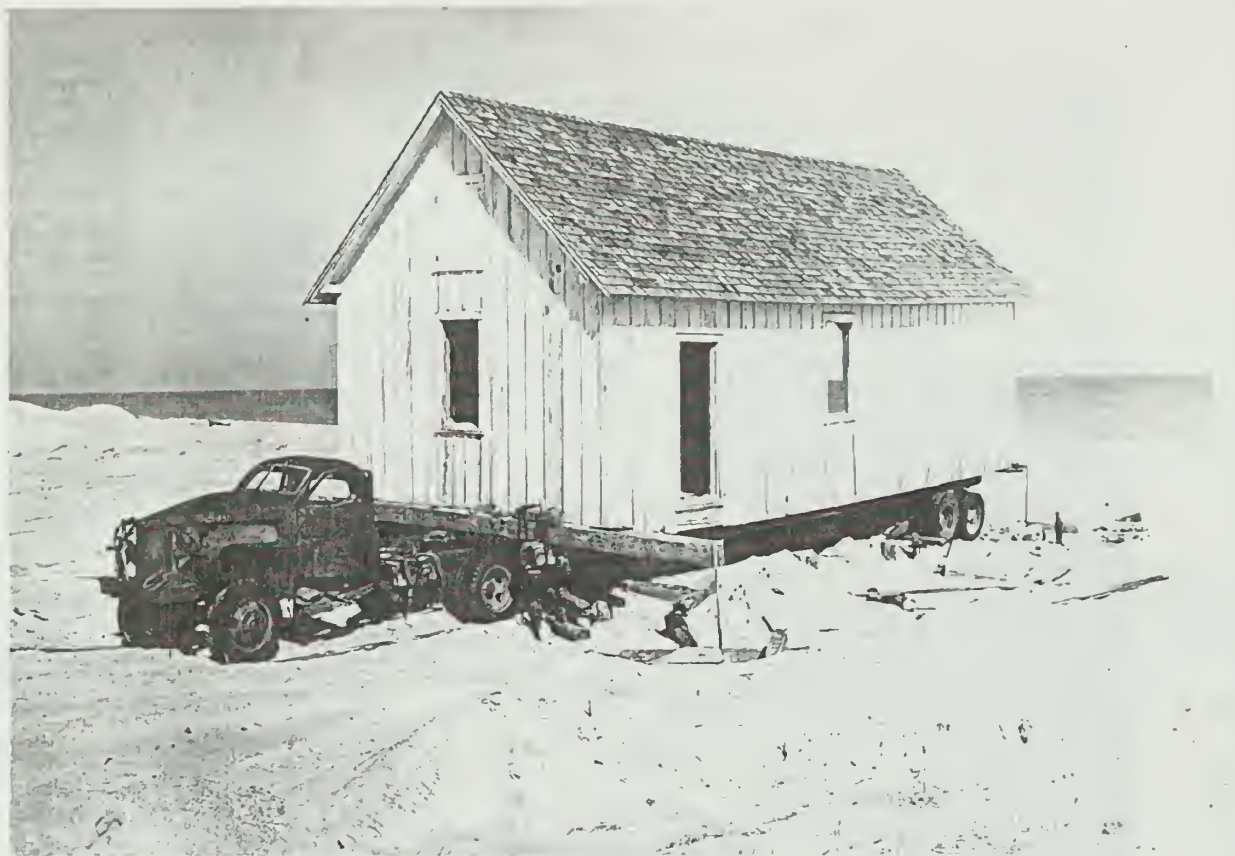
- I.19 1879 Station from the east, Jan. 31, 1955. Label – “Neg. No: 55-21, Date: 1/31/55, Print File: St/M, General Description, Location, Other pertinent Data: Supt. Residence being moved. Negative by: A.D.” [Albert Dillahunt]. Shows east facade with two south windows added, original window under the dormer, door added at the north end, and scar of exterior chimney in north gable end.

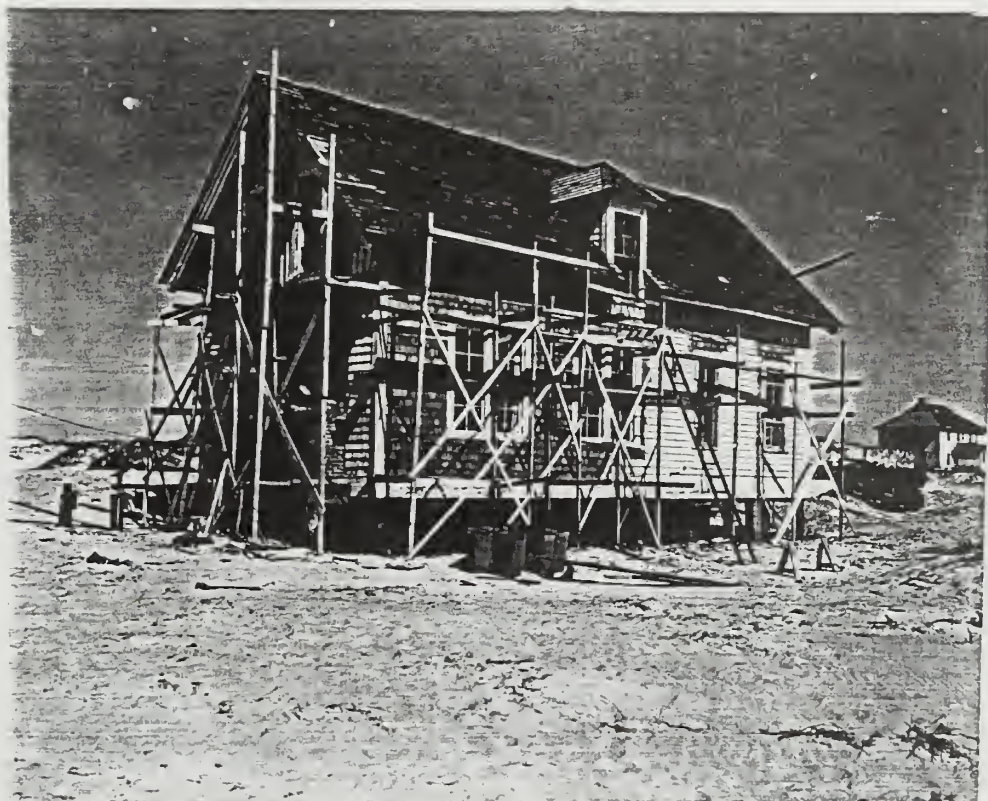
I.20 1916 boat house from the southwest, Feb. 8, 1955. Label – “Neg. No: 55-?, Date: 2/8/55, Print File: St/M, General Description, Location, Other pertinent Data: B.I. Boat House (Supt. garage) being moved. Negative by: Albert Dillahunty Large print?” Shows north and west elevations.
